Manhole Inspection Summary

Manhole # S11AA1016MH

Location Address: **REAR- 3324 DOLFILELD AVE** Cross Street: **EDGEWOOD RD**

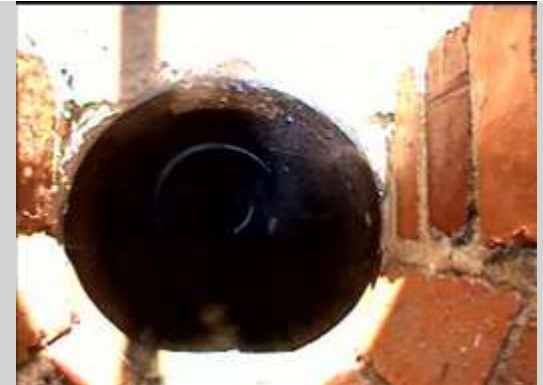
12 O'Clock Outflow

8 in. Circular Gravity Sewer
Pipe Out @ 12 O'Clock

Pipe Material: **Clay** ☐ Pipe Lined

Invert Depth: **7.86** (ft.) Flow Characteristics: **Slow**

Deposits: ☒ None ☐ Mud ☐ Sludge ☐ Debris ☐ Grease

Infiltration: **None** Pipe Seal Cond: **Sound**

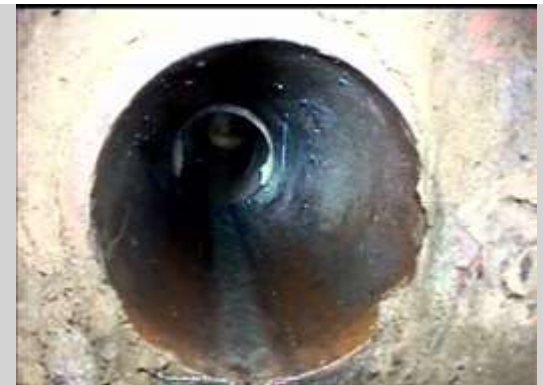
6 O'Clock Inflow

8 in. Circular Gravity Sewer
Pipe In @ 6 O'Clock

Pipe Material: **Clay** ☐ Pipe Lined

Invert Depth: **7.45** (ft.) Flow Characteristics: **Slow**

Deposits: ☒ None ☐ Mud ☐ Sludge ☐ Debris ☐ Grease

Infiltration: **None** Pipe Seal Cond: **Sound**

Connects To: **Stub connection / abandoned**

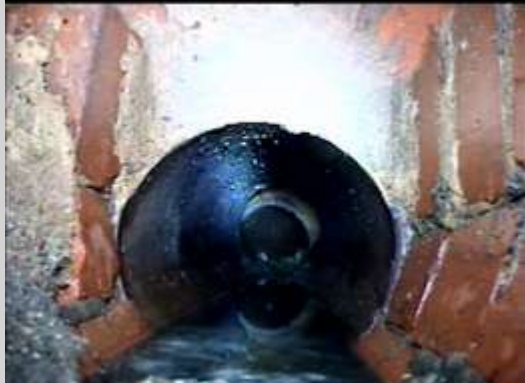
7 O'Clock Inflow

6 in. Circular Gravity Sewer
Pipe In @ 7 O'Clock

Pipe Material: **Clay** ☐ Pipe Lined

Invert Depth: **7.72** (ft.) Flow Characteristics: **Slow**

Deposits: ☒ None ☐ Mud ☐ Sludge ☐ Debris ☐ Grease

Infiltration: **None**

Pipe Seal Cond: **Sound**

Connects To: **House connection / Service line**
